Karst of the Belfast and Sugar Tree Ridge 7.5-Minute Quadrangles, Ohio

by
Douglas J. Aden

Open-File Report 2016-4
Columbus 2016

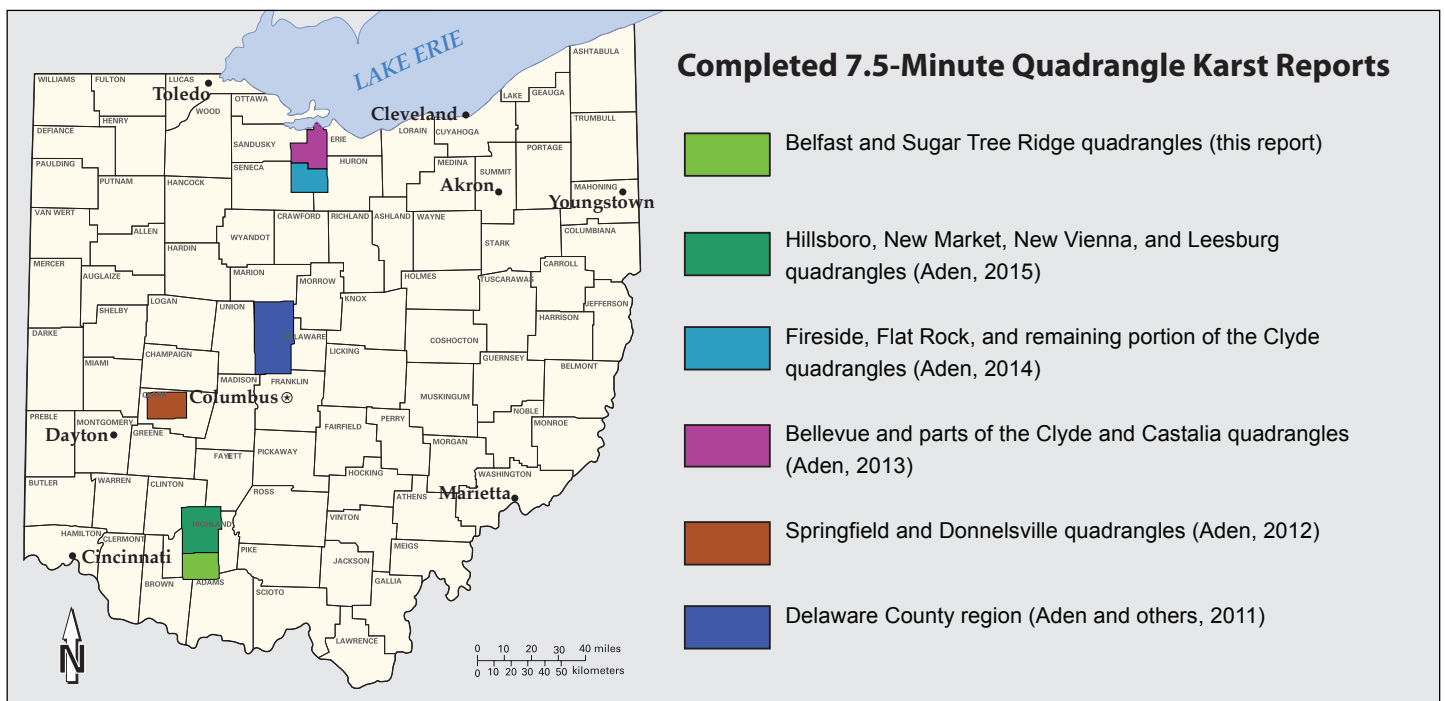
FIGURE 1. Locations of completed quadrangle-based karst reports in Ohio since 2010. The Delaware County regional study included six full quadrangles and parts of 14 other quadrangles in the region.

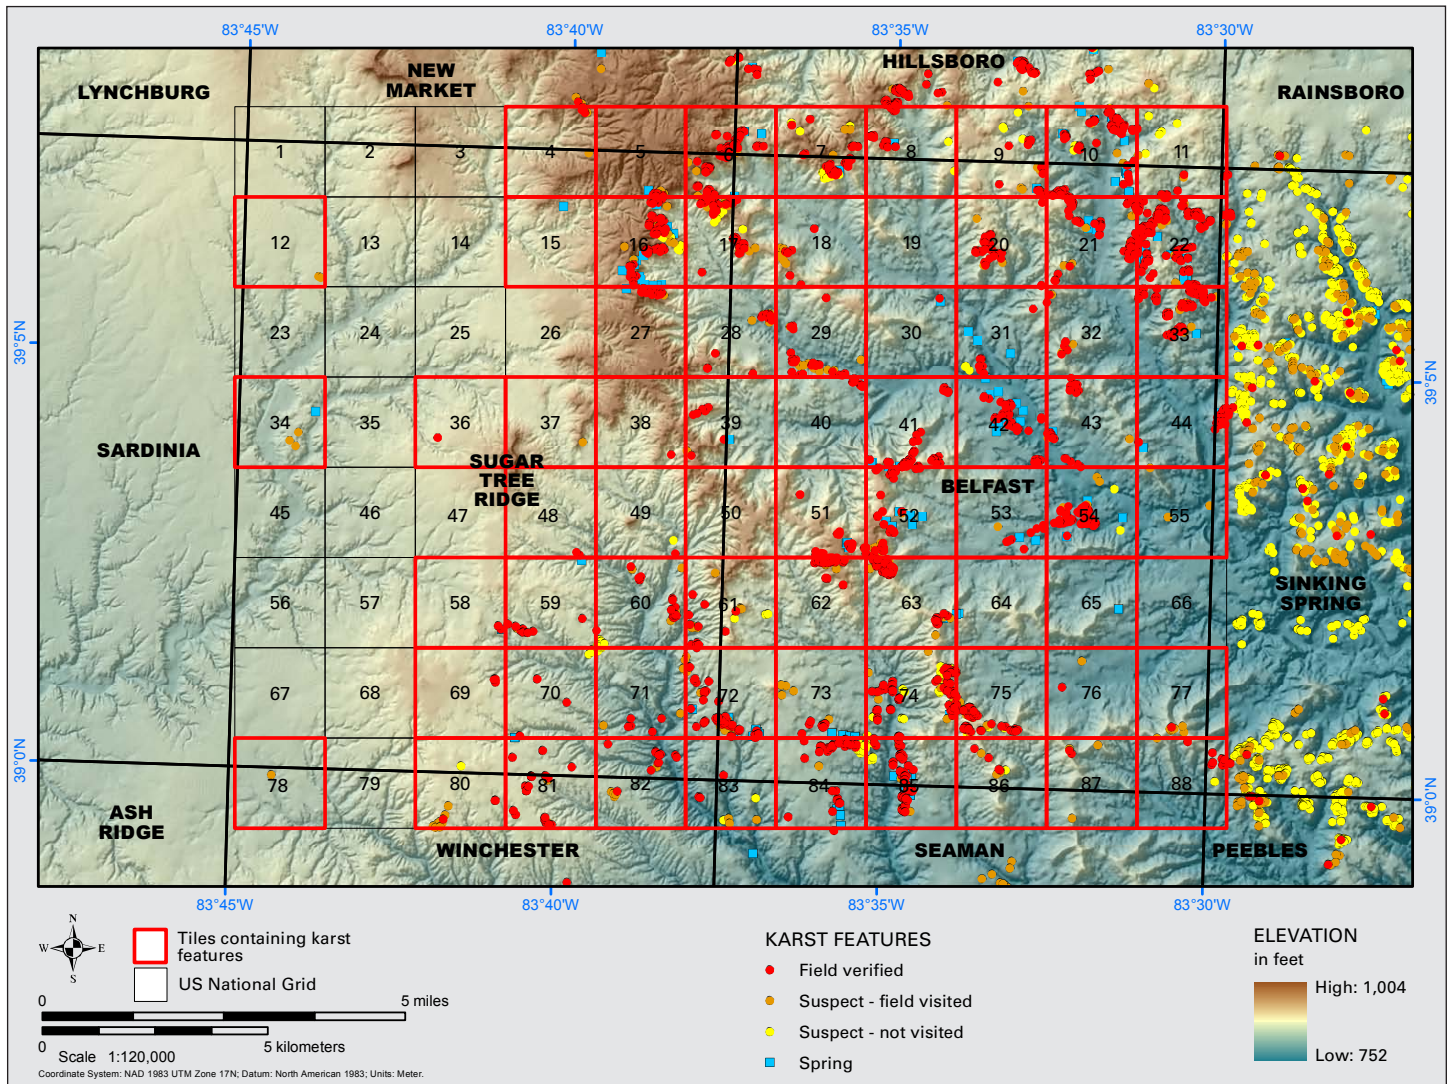
FIGURE 2. Digital elevation model (Land Surface map) showing topographic relief in the study area.

The resulting karst feature data set was overlain on a reference map and four geologic maps showing the Land Surface, Bedrock Geology, Bedrock Topography, and Drift Thickness. The Land Surface map (fig. 2) shows the 88 two-km² tiles and the 7.5-minute quadrangles that form the project area overlain on a DEM of the land surface. The Land Surface map of the Belfast region shows a concentration of sinks, near the break in slope at the tops of hills, that often occur in clusters. A strong directional trend was not observed in this project area.

is called *bedrock topography* and is shown on fig. 4. The elevations of the bedrock surface were subtracted from the DEM (fig. 2) to create the Drift Thickness map (fig. 5). Knowing the drift thickness is useful because sinkholes generally develop where the drift is shallow (about 25 feet or less). Other sinkholes may exist in areas that have more than 25 feet of drift, but they were either buried beneath the glacial drift or

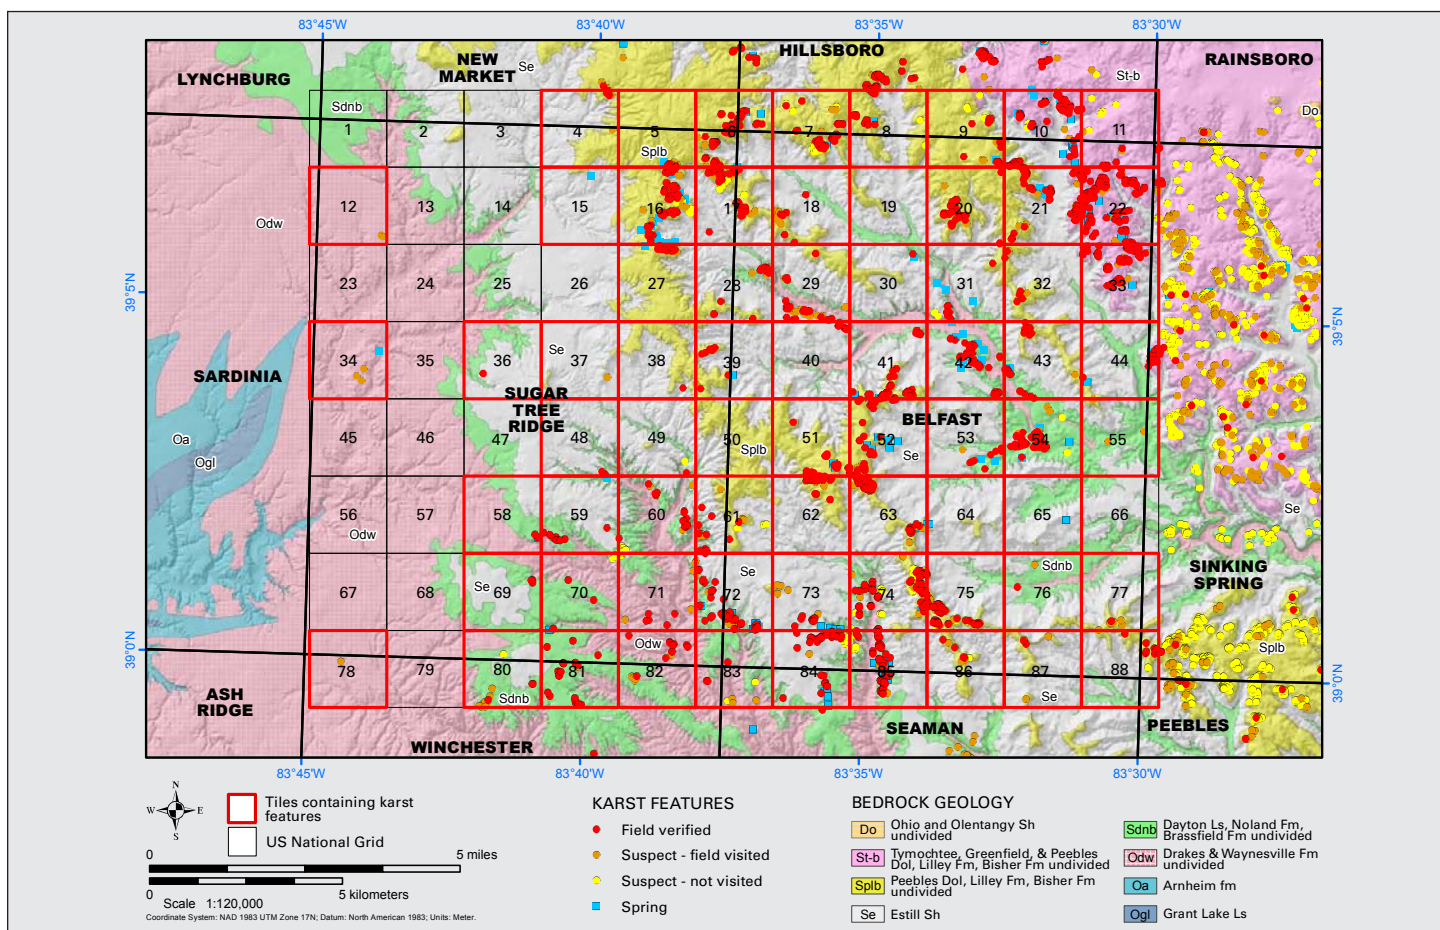
FIGURE 3. Lithified rock (bedrock geology) at the surface or beneath glacial material in the study area.

The Bedrock Geology map (fig. 3) shows that the karst features are forming primarily by dissolution of Silurian-age Peebles, Lilley, and Bisher Dolomites (table 1). Most well-developed karst is expressed as steep-walled, cone-shaped depressions with active sinking and a sink throat where water drains.

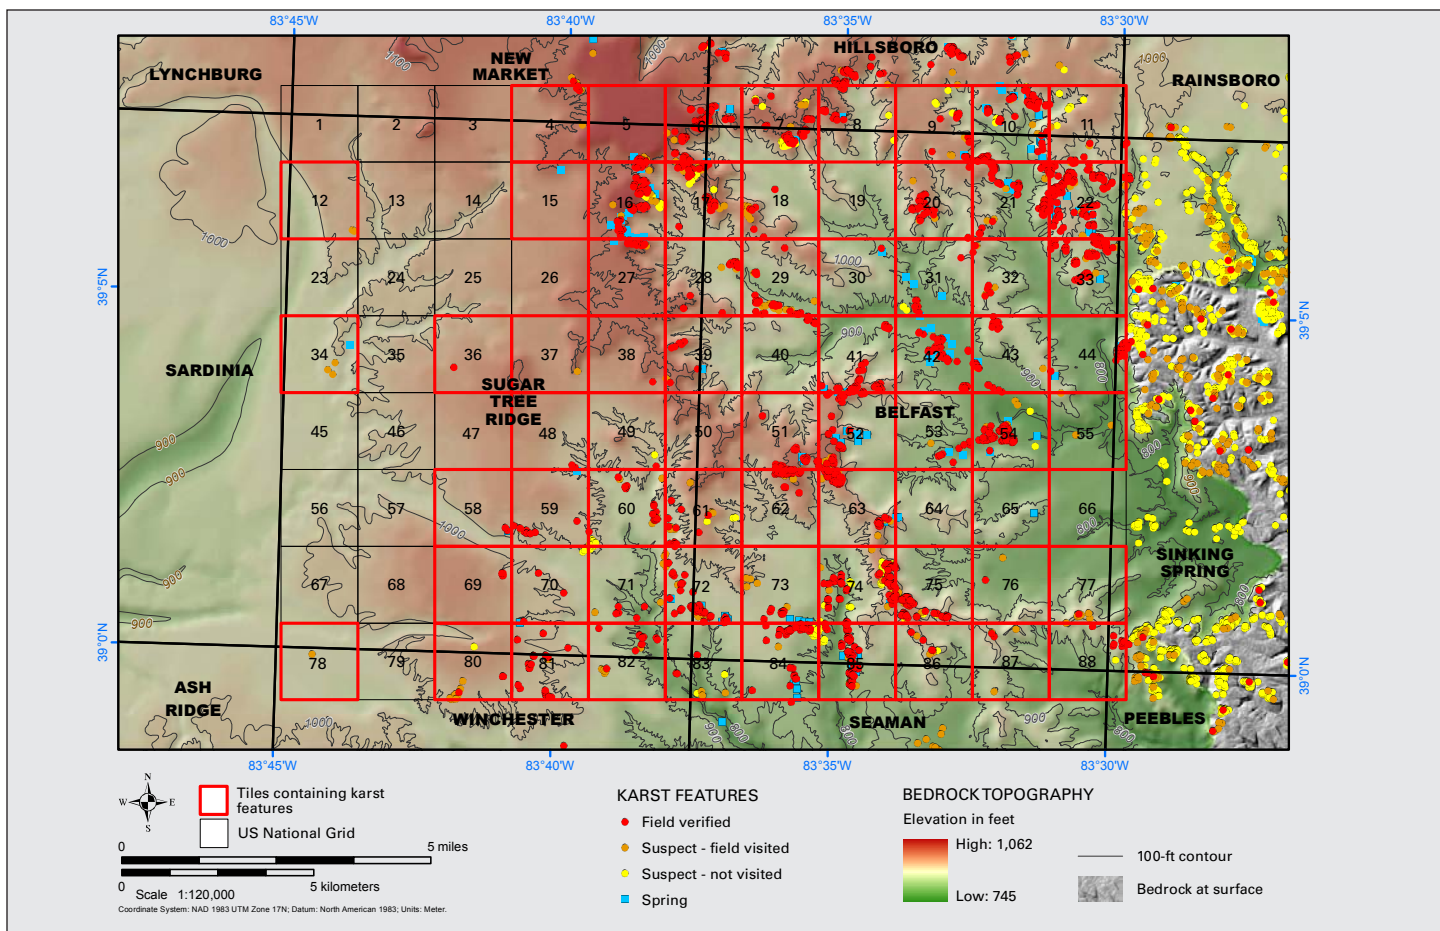
FIGURE 4. Bedrock topography in the study area.

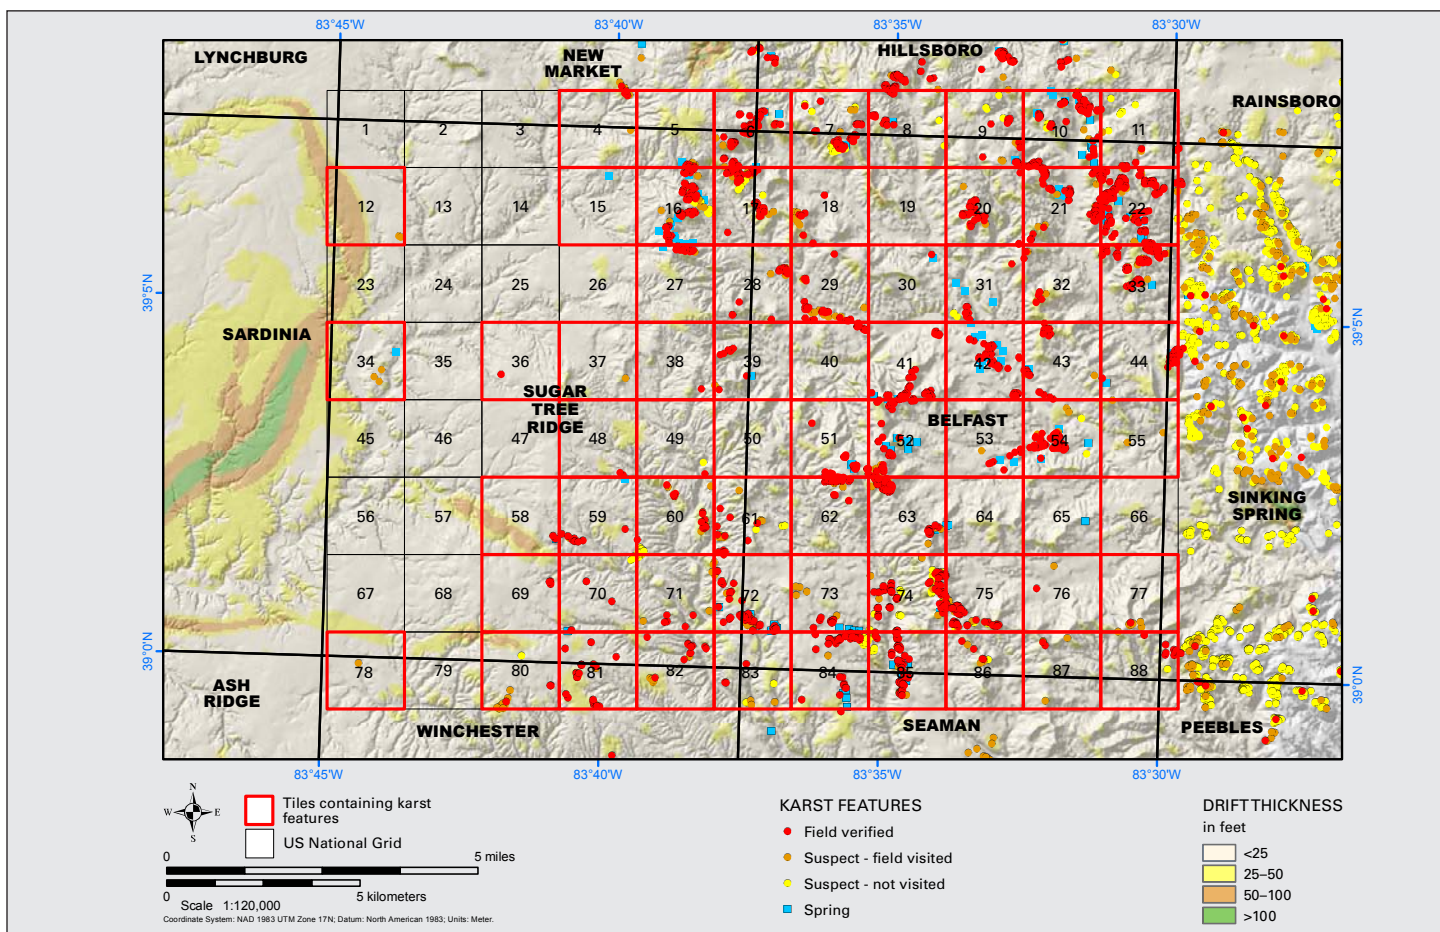
FIGURE 5. Thickness of glacial material (DEM minus Bedrock Topography) in the study area.

prevented from forming because of thick drift. The Belfast Drift Thickness map clearly shows the sinkholes are concentrated along areas of thin glacial drift (fig. 5).

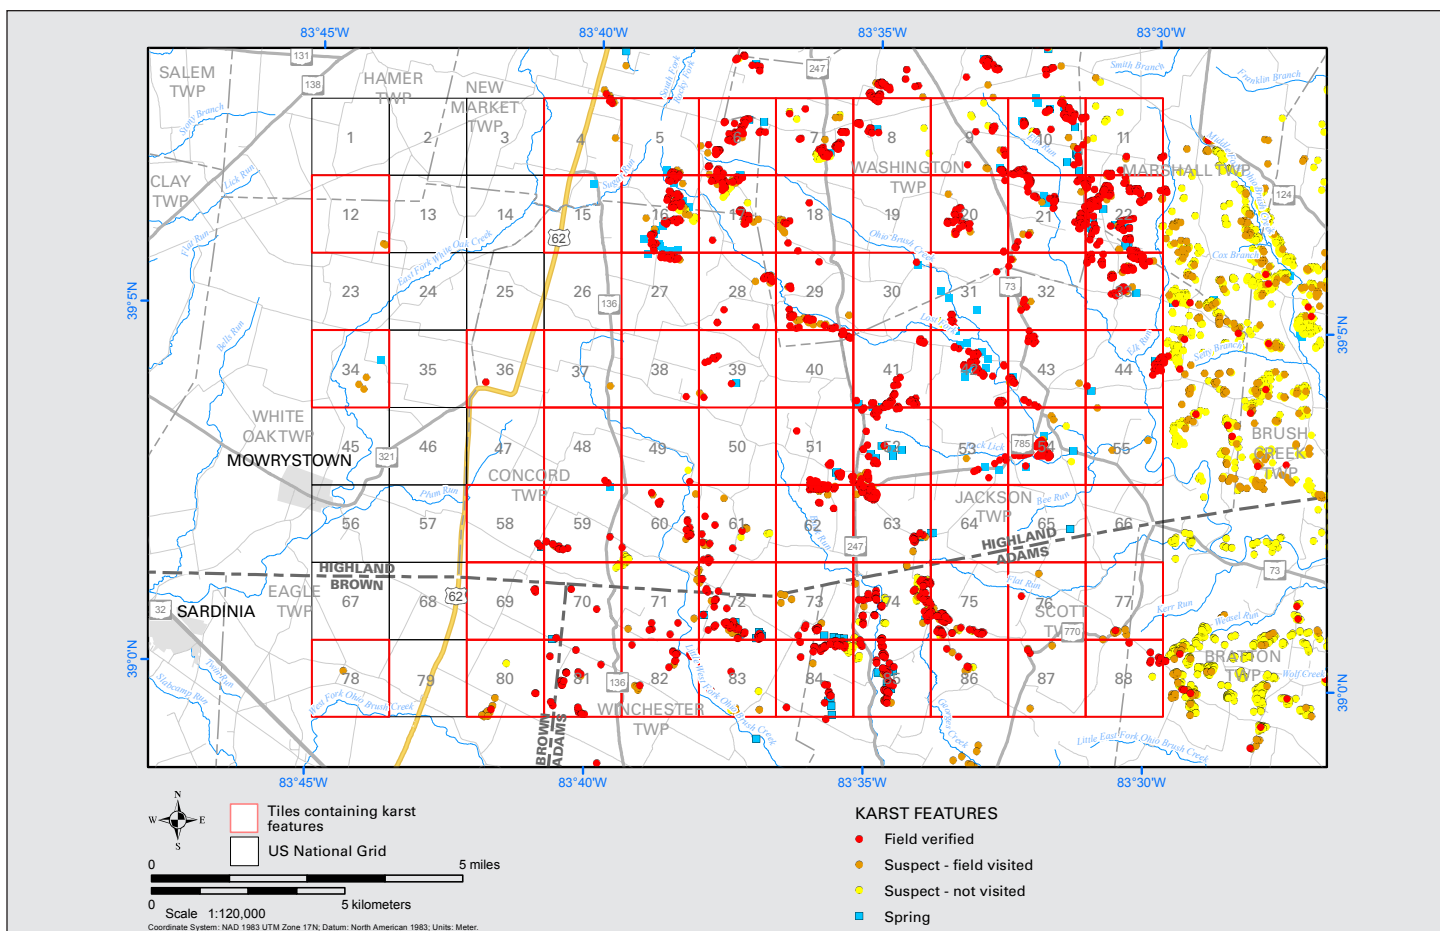
FIGURE 6. Reference map of the study area showing counties, townships, roads, towns, and streams.

point and tile locations relevant to the roads, streams, counties, and townships (fig. 6).

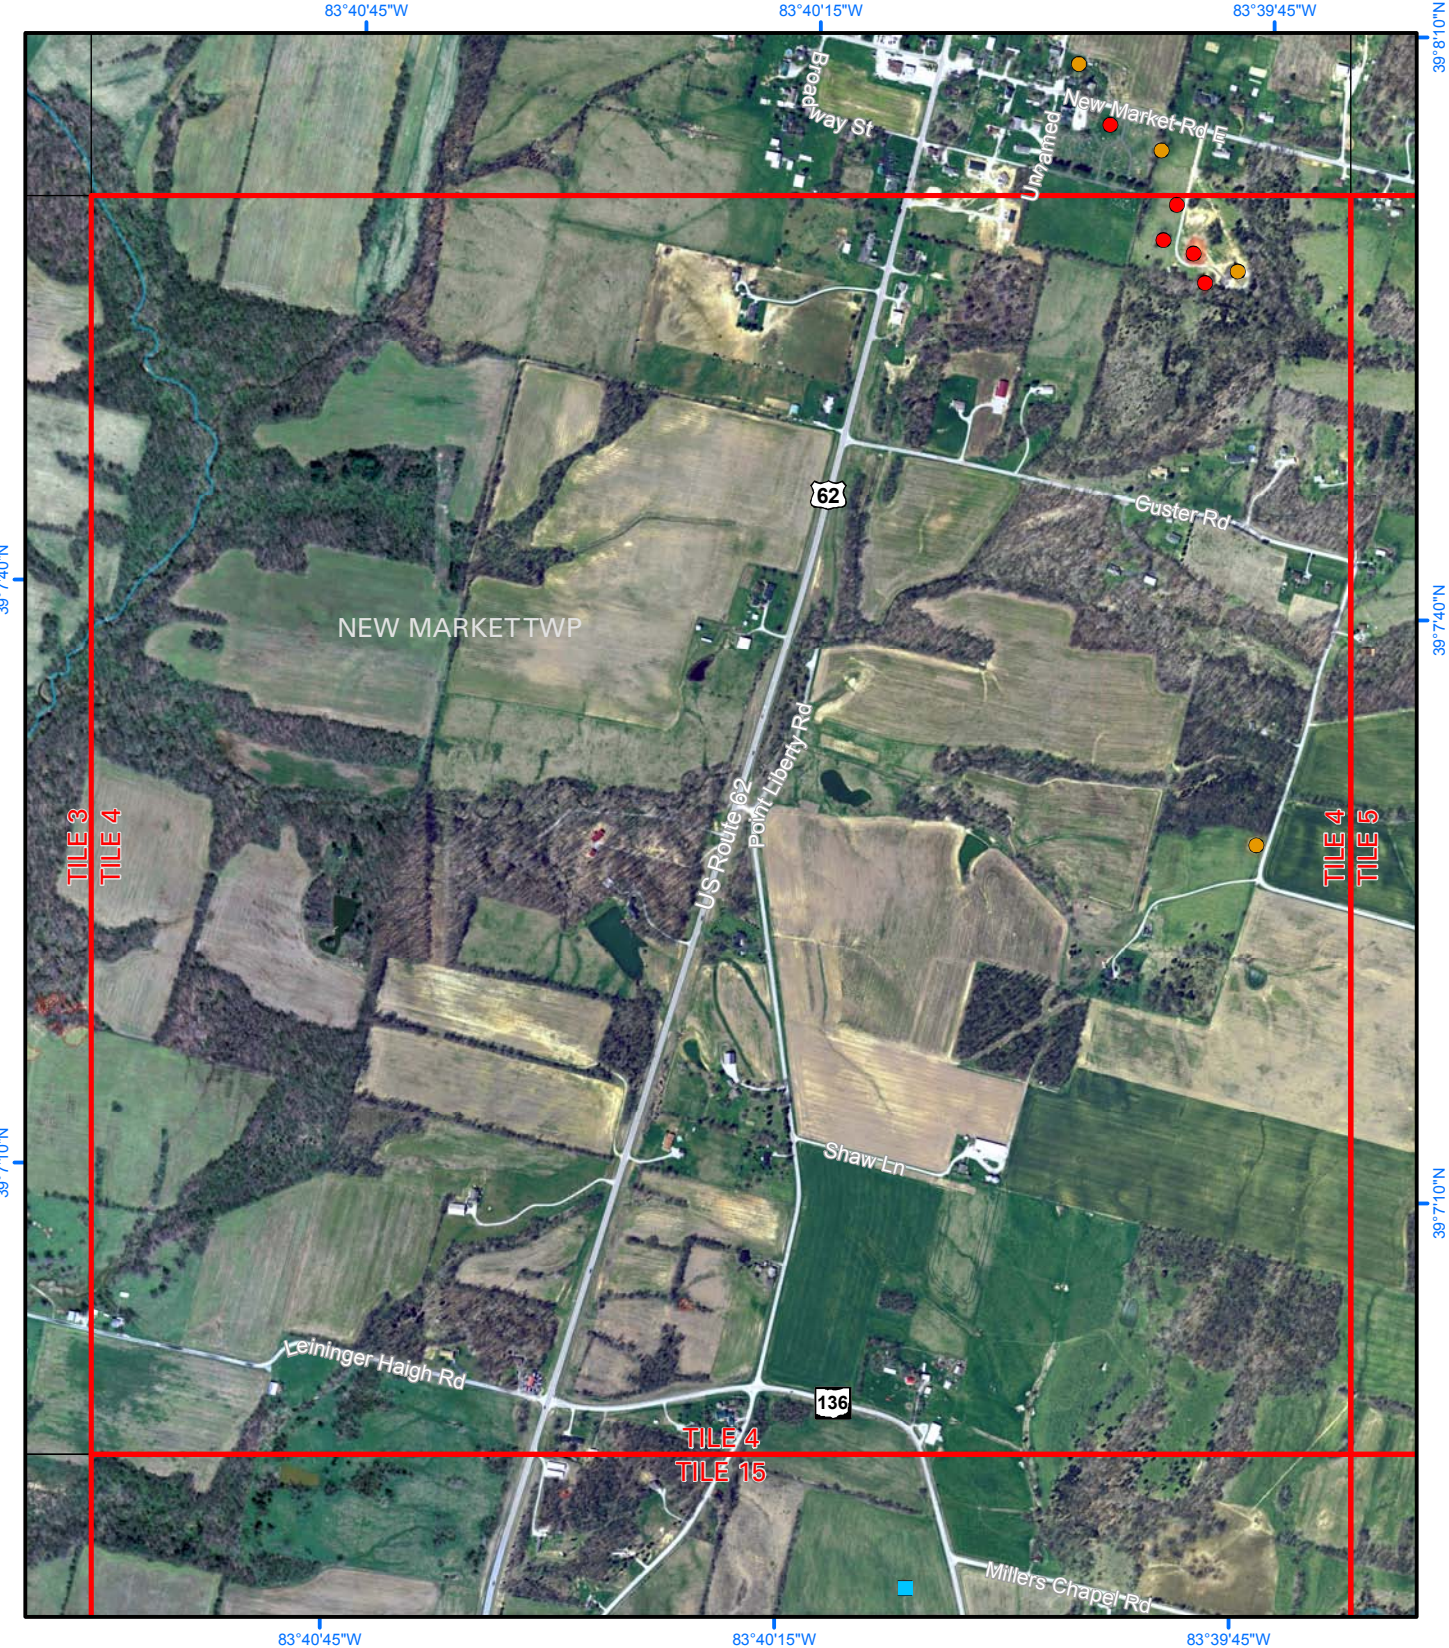
Tile Number: 4

Detailed two-km² map tiles (p. 8–74) contain specific karst point locations. Also included on these maps are karst depressions represented by yellow to red topographic lines. Each concentric ring represents a drop of one foot in elevation toward the low point of an internally drained area. Many of the depressions are covered by the points because the depressions are so small at the scale of the tiles.

- KARST FEATURES**
- Field verified
 - Suspect - field visited
 - Suspect - not visited
 - Spring
